# RAPPAHANNOCK RIVER BASIN

Name Of Dam: White Oak

Inventory Number: VA 11301

## PHASE I INSPECTION REPORT NATIONAL DAM SAFETY PROGRAM

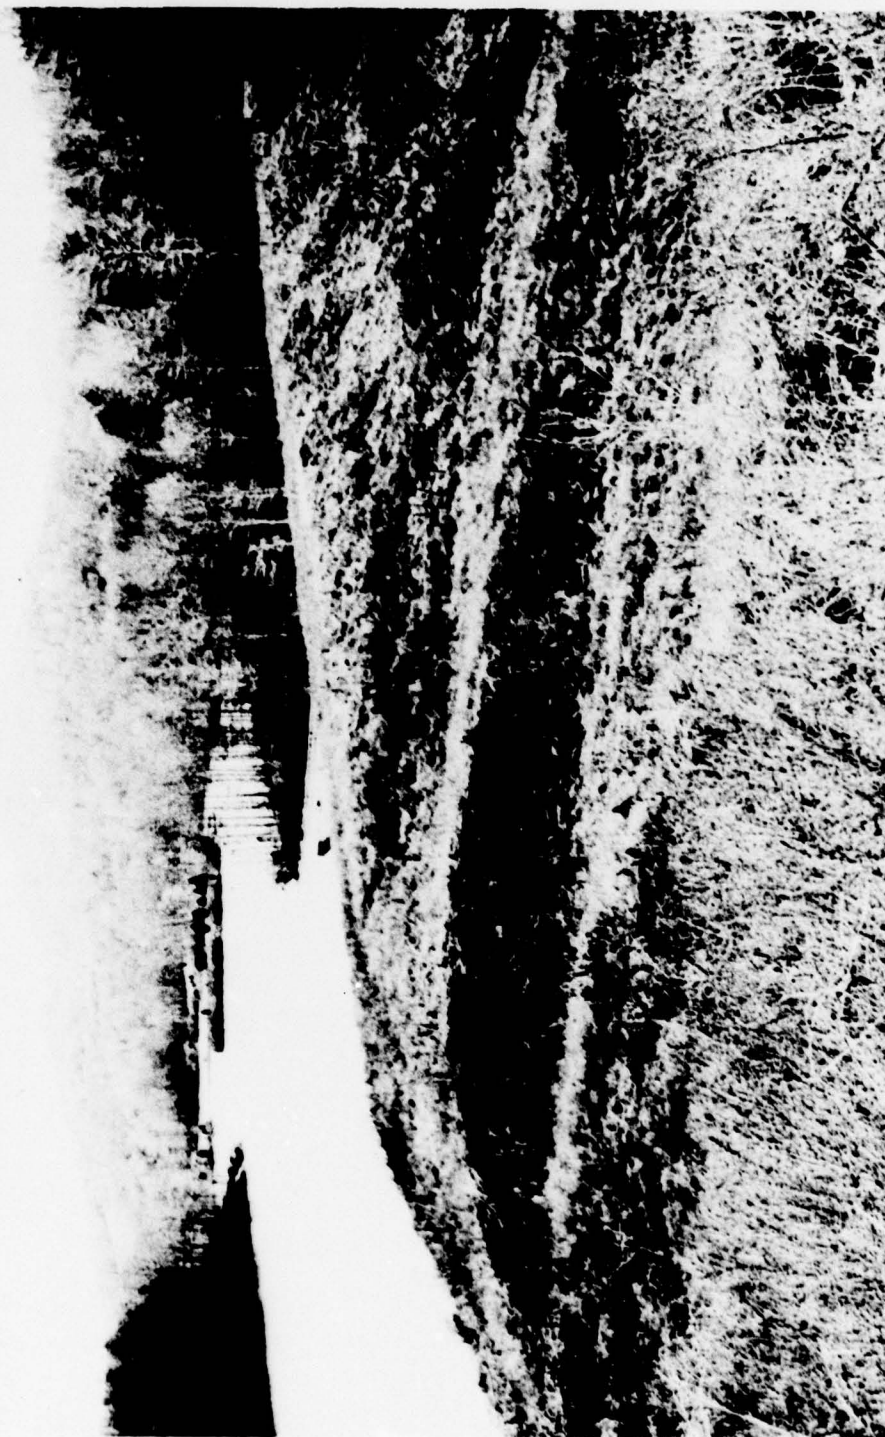
OVERALL VIEW OF DAM

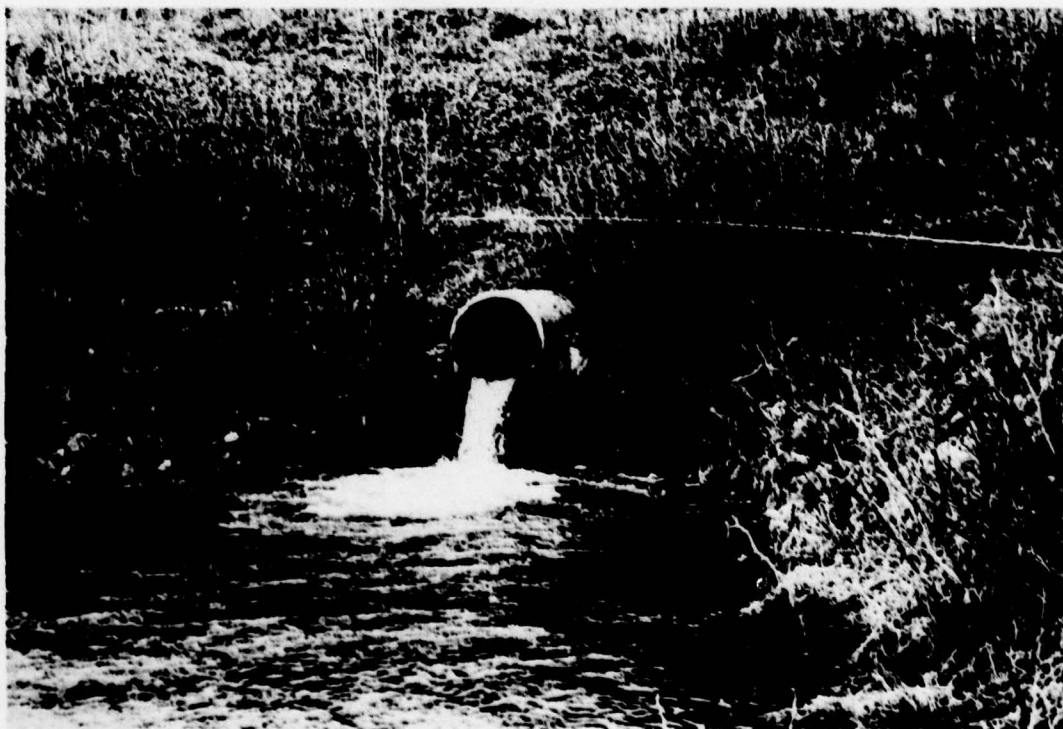
- 3.1.5 Downstream Channel: The stilling basin (see Photo 2) and outlet channel are functioning properly, and the riprap is generally in good overall condition. A slide-erosion area 20 feet wide by 18 feet high (see bottom of Photo 4) occurs on the right of the stilling basin approximately 30 feet from the toe of the dam. The slide-erosion area has displaced some riprap.

**PHOTO 2. Concrete Outlet Pipe and Stilling Basin**
